USAARL Report No. 93-22

Laboratory Test and Evaluation of the Litton Model F15E Molecular Sieve Oxygen Generating System

June 1993

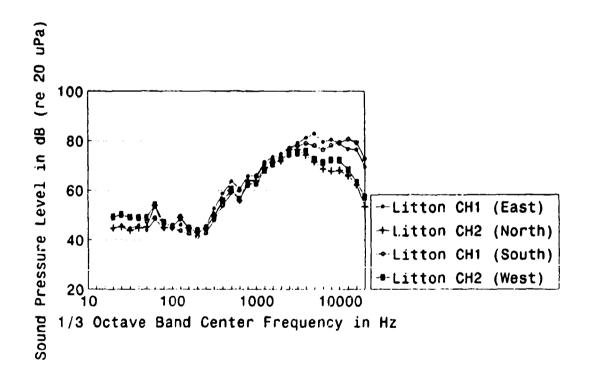
Sound Measurements

1.5.6 Acoustical Analysis: The Litton MSOGS produces a significant amount of noise. Noise levels from 60 dB to 80 dB were measured from 1000 to 10,200 Hz. The peak noise level was 82.9 dB.

The Litton Model F15E produces a noise which is subjectively loud. The peak noise level was 82.9 dB. Noise levels from 60 dB to 80 dB were produced in the 1000 Hz to 10,200 Hz range. Additional testing when the unit is installed will be required to properly evaluate this criterion for operation in the aircraft. Criterion not evaluated.
